Manhole Inspection Summary

Manhole # S13C1_021MH

Location Address: **S Caton Ave**

Cross Street: **Clarinda Ave**

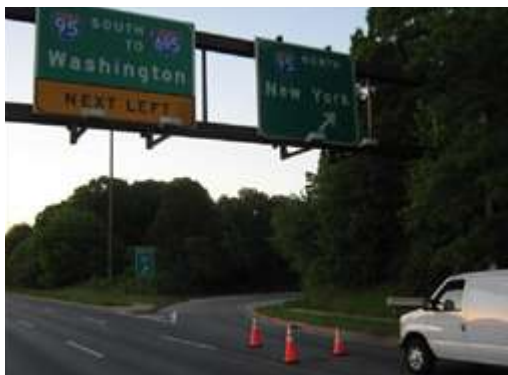
Location View

South Caton Ave

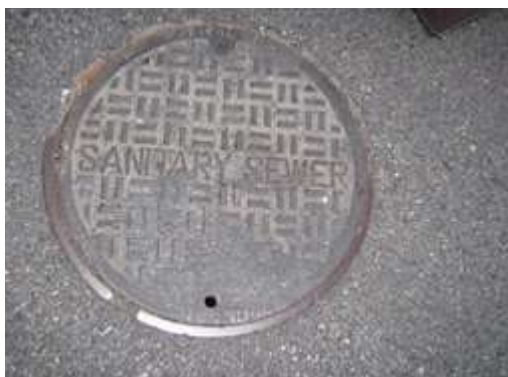
Miscellaneous

mh cover

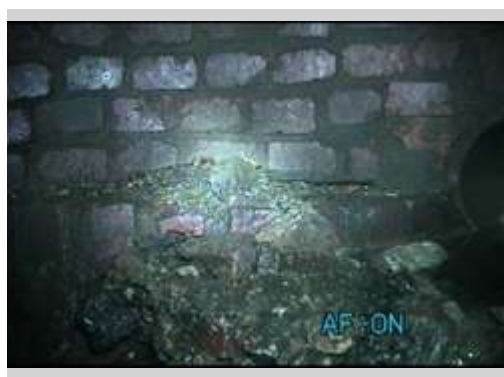
Defect 4

Condition: ☐ Sound ☐ Cracked ☐ Root Intrusion ☐ Deteriorated ☐ Leaks ☒ **Debris**

debris on bench

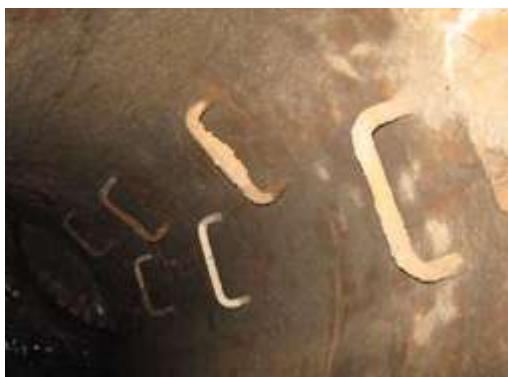
Defect 3

Infiltration: ☐ None ☐ Joint ☐ Cracks ☐ Mortar ☐ Roots ☒ **Wall**

Count: **6** Missing: **0** ☒ **Corroded**

seepage infiltration all along barrel walls;
corroded rungs

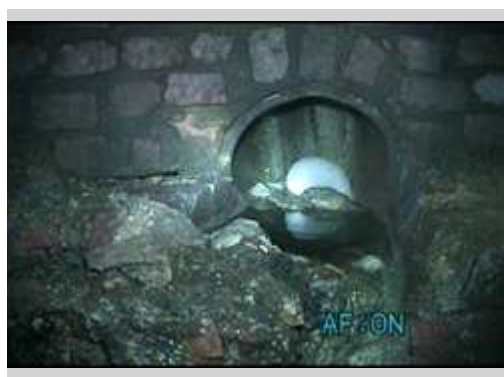
Defect 1

Condition: ☐ Sound ☐ Cracked ☐ Root Intrusion ☐ Deteriorated ☐ Leaks ☒ **Debris**

debris in I3 channel

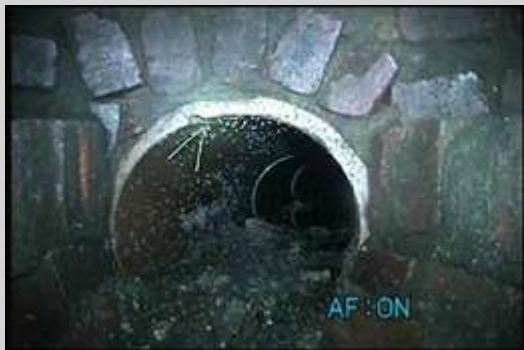
9 O'Clock Inflow

Deposits: ☐ None ☐ Mud ☐ Sludge ☒ **Debris** ☐ Grease

Silt Depth: **0** (in.) Deposits Extent: **Light**
